3. Recipient's Catalog No.	
4. Title and Subtitle NCHRP REPORT 350 TEST 3-11 OF THE WASHINGTON 3-STRAND CABLE BARRIER WITH NEW YORK CABLE TERMINAL		5. Report Date March 2000

6. Performing Organization Code	
7. Author(s) D. Lance Bullard, Jr., Wanda L. Menges, C. Eugene Buth, and Sandra K. Schoeneman		8. Performing Organization Report No. 404211-8

9. Performing Organization Name and Address Texas Transportation Institute The Texas A&M University System College Station, Texas 77843-3135		10. Work Unit No. (TRAIS)

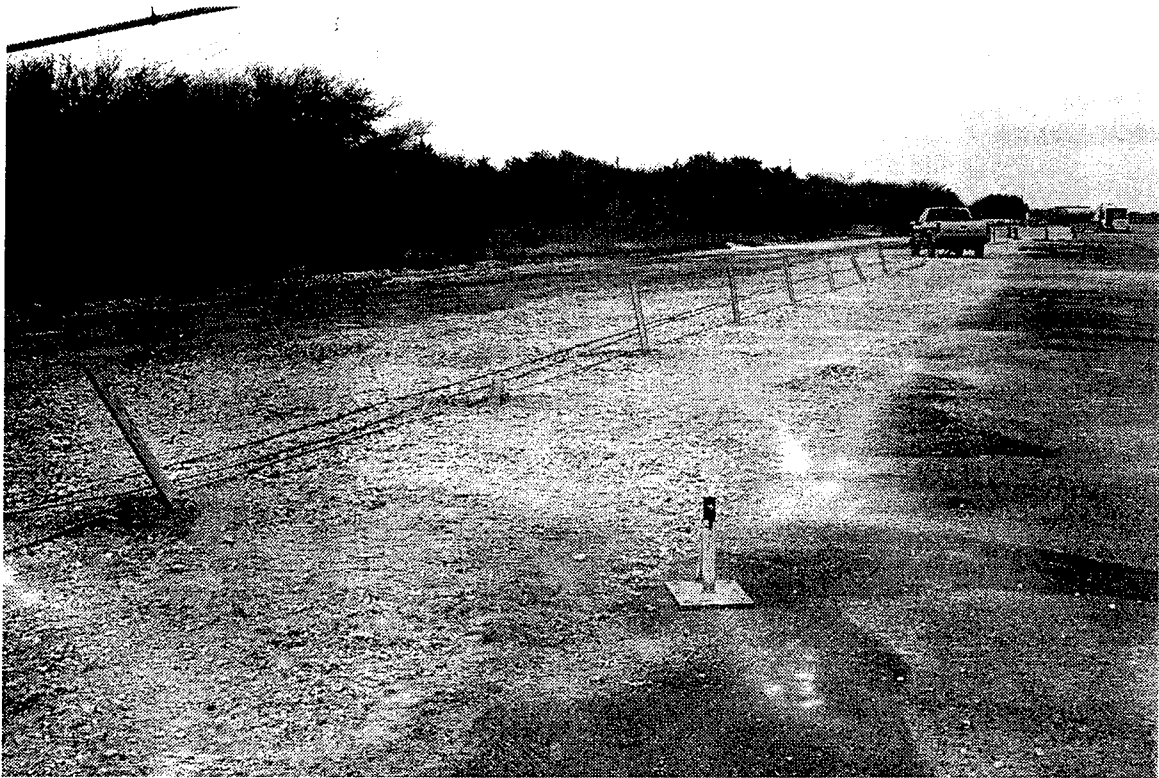
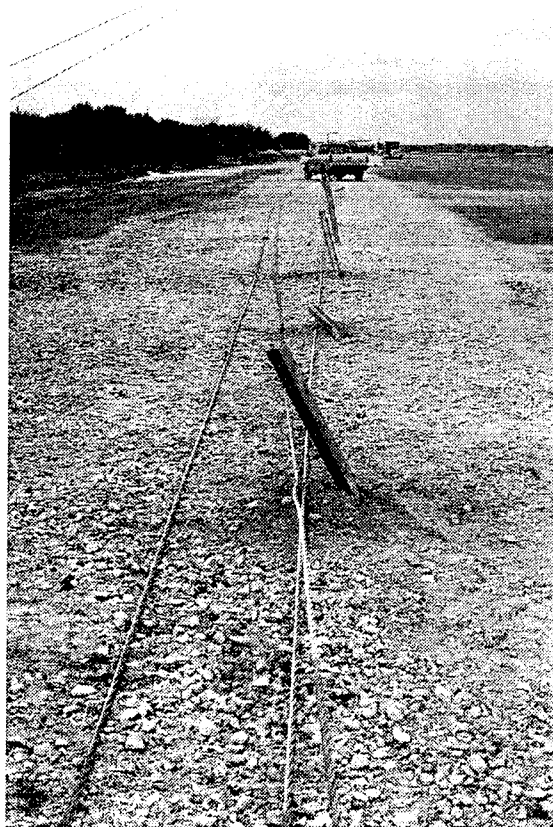
Figure 7. Vehicle trajectory path after test 404211-8.

at 0.412 s, and at 0.417 s, post 15 moved. By 0.425 s, the upper cable detached from post 17, and by 0.449 s, post 16 moved. The vehicle began to travel parallel with the test installation at 0.464 s and was traveling at a speed of 83.6 km/h. The middle cable rode over the top of post 15 at 0.465 s. At 0.536 s, the middle cable detached from post 16, and at 0.561 s, the front wheels began to steer toward the cable barrier. The middle cable rode over the top of post 16 and post 17 began to deform toward the field side of the installation at 0.653 s. By 0.665 s, the vehicle began to yaw toward the cable barrier, and by 0.819 s, the middle cable rode over the top of post 17. At 0.970 s, the vehicle began to be pulled sideways toward the posts, and at 1.613 s, the vehicle was again parallel with the installation. The side of the vehicle contacted post 18 at 1.705 s, and at 1.895 s, the front bumper makes contact with the post. The vehicle, traveling parallel with the installation, then yawed toward the rail. At this point, 65 percent of the vehicle was estimated to be on the back side of the posts at 2.550 s. The vehicle stopped moving forward at 3.915 s, and at 4.035 s, the front wheels of the vehicle straighten as the vehicle began moving backwards. The vehicle stopped moving at 5.547 s. Brakes on the vehicle were not applied and the vehicle subsequently came to rest on top of post 22. Sequential photographs of the test period are shown in appendix C, figures 14 and 15.

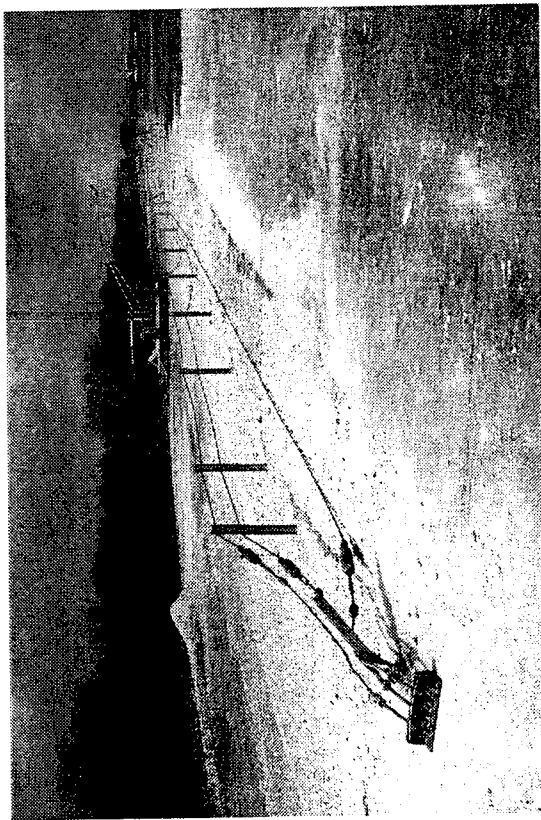
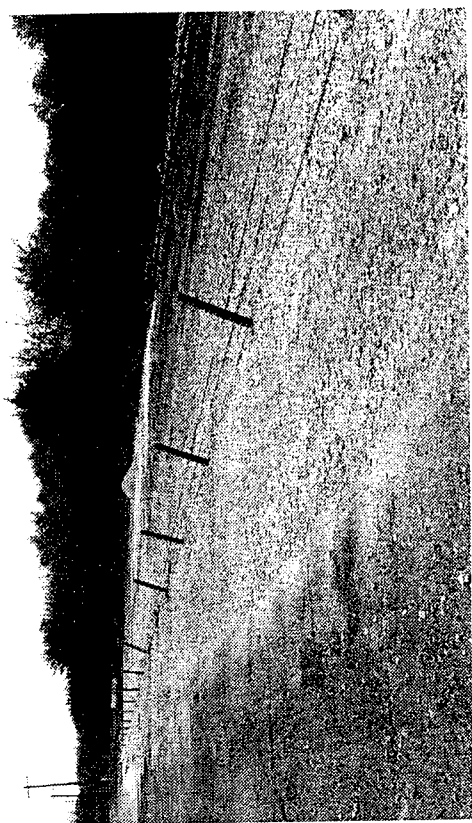
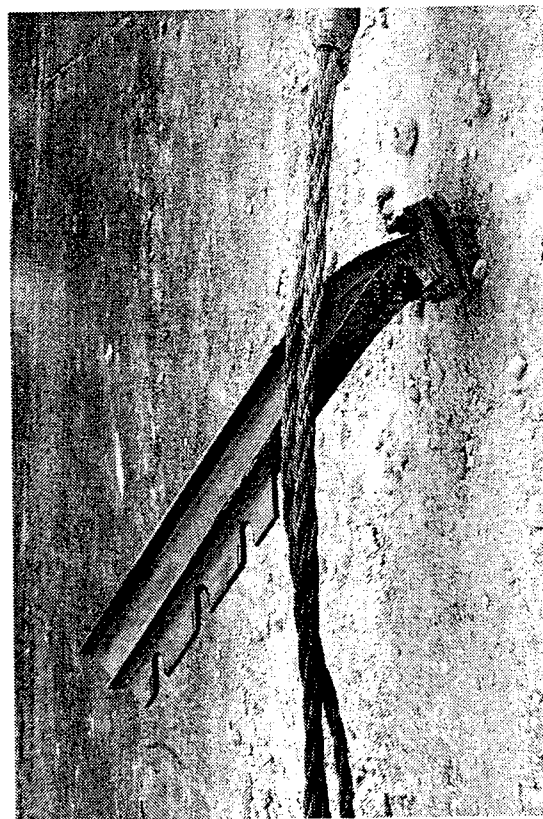
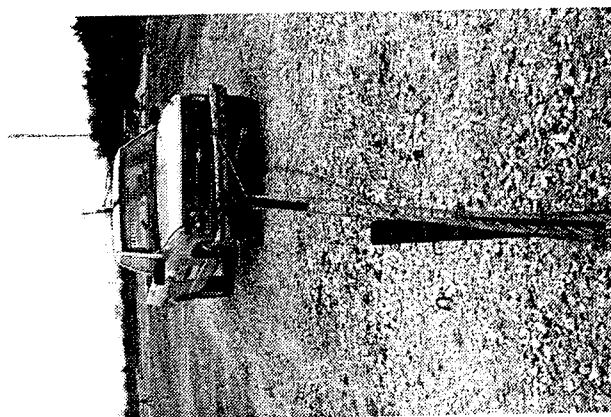
Figure 8. Installation after test 404211-8.

Other than damage to the posts, damage to the Washington 3-strand cable barrier was minimal as shown in figures 7 through 9. The upstream anchor had minor stress cracks radiating from the anchor bolts in the concrete footing. Post 1 moved 670 mm longitudinally downstream. Posts 2 through 9 were disturbed and posts 10 through 15 were displaced 25 mm, 13 mm, 40 mm, 45 mm, 15 mm and 40 mm, respectively. Posts 11 through 17 were rotated and post 12 was torn on the flange above the soil plate. The downstream anchor moved 5 mm longitudinally upstream. The cables were slack throughout the length of the installation. Maximum dynamic deflection during the test was 3.4 m.

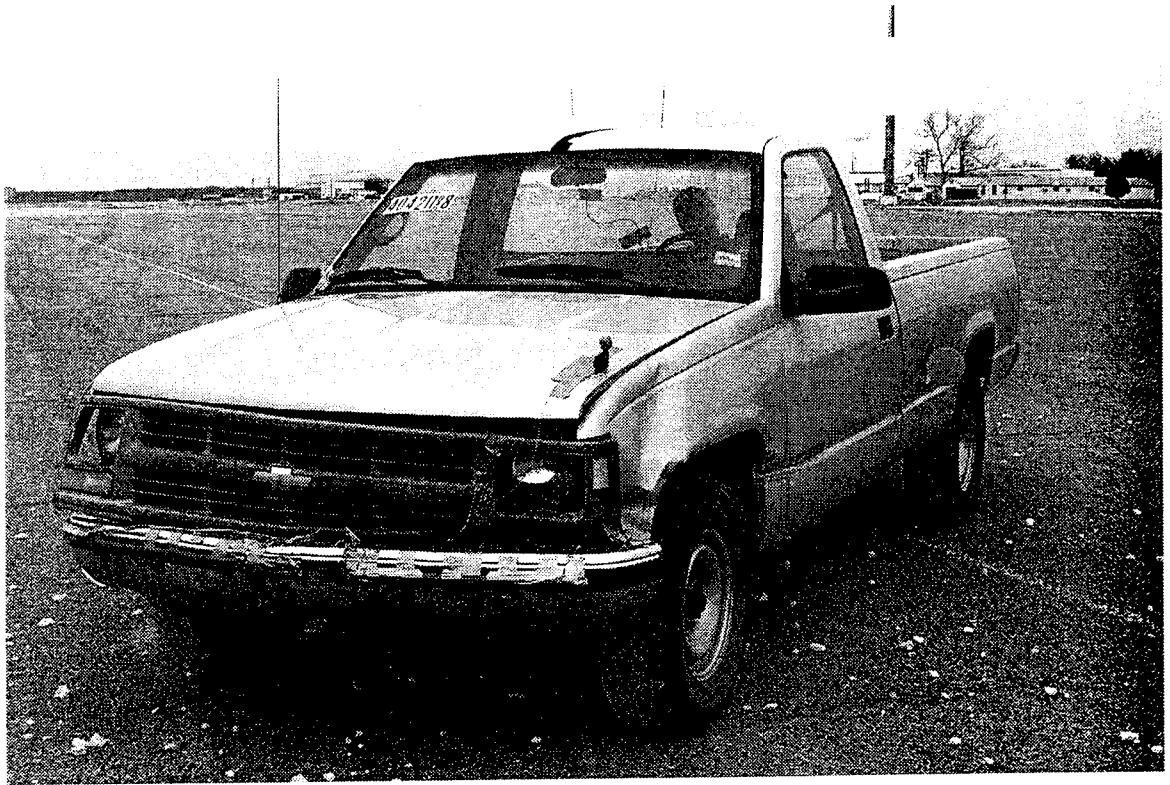
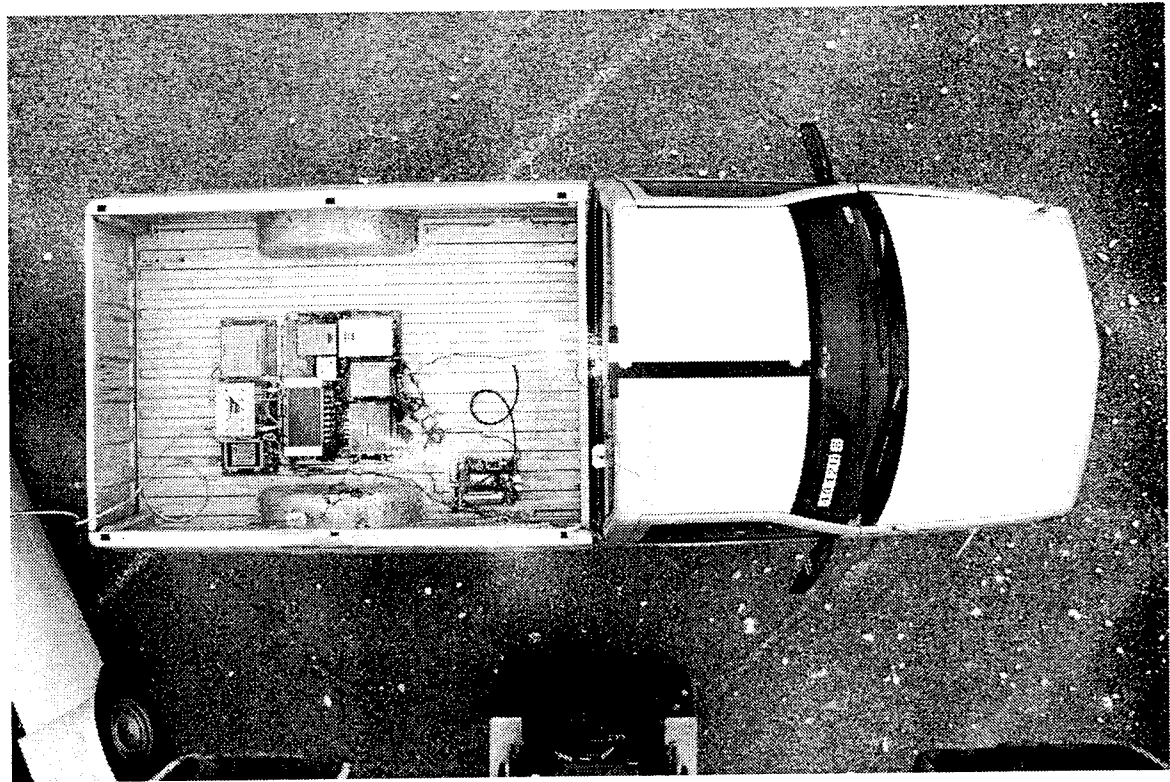
Figure 10. Vehicle after test 404211-8.

The vehicle sustained minor damage as shown in figure 10. There were scuff marks on the left front and rear quarter panels and left door. In addition, the left front and rear tires were cosmetically damaged. Maximum exterior crush to the vehicle was 320 mm above the front bumper at the left front corner. No deformation or intrusion into the occupant compartment occurred from the impact with the cable barrier. The interior of the vehicle is shown in figure 11. Exterior vehicle crush and occupant compartment measurements are shown in appendix B, tables 3 and 4.
